NASA Technical Paper 1609

Scanning-Electron-Microscope Study of Normal-Impingement Erosion of Ductile Metals

William A. Brainard and Joshua Salik

JANUARY 1980

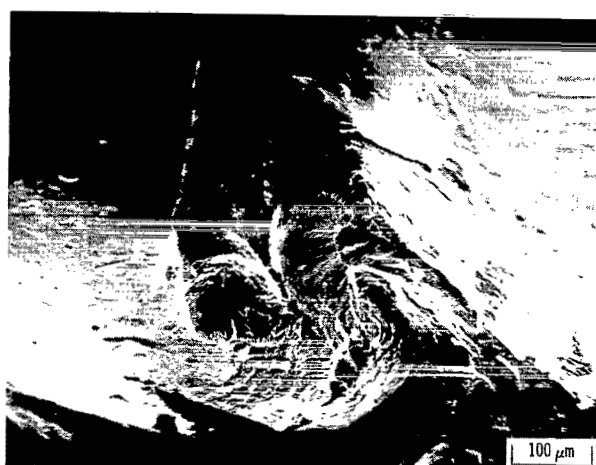
Figure 3. - Annealed 6061 aluminum surface after adjacent impacts by 3.2-millimeter-diameter steel ball at 140 meters per second.

per second. Of particular interest are the region between two adjacent impacts and the region below (subsurface) the impact zone. Figure 3 presents higher magnification micrographs, in this case from an aluminum surface, of the extruded metal peaks. Note in particular the extensive cracking and the layer-like structure. Very thin lamellae of aluminum were observed to occur on the sides and bottoms of impact craters (fig. 4). Such lamellae are likely to be easily detached on subsequent impacts. Transfer of aluminum in very thin layers to a steel ball on impact had been confirmed by X-ray analysis (ref. 12). The amount of transferred material per impact seemed to increase with the number of impacts.

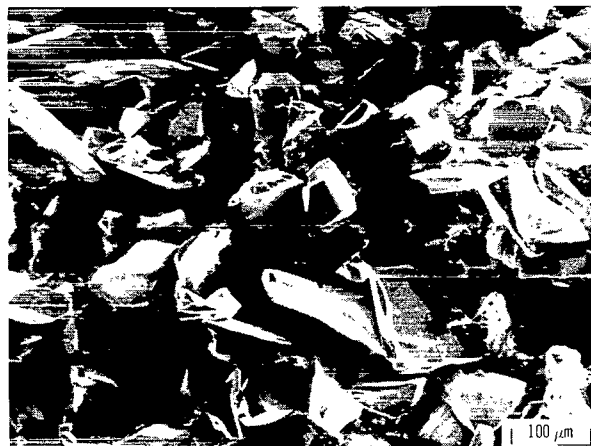
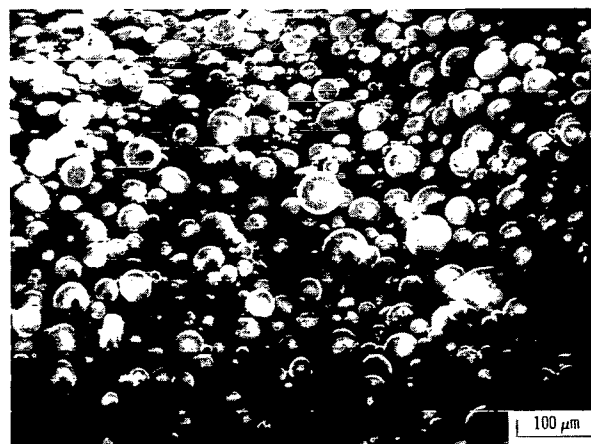
(a) Silicon carbide particles.

(b) Glass beads.

Figure 9. - Erodant particles.

Most erosion-causing particles in actual operating systems are considerably smaller and more angular than the steel balls used for the experiments described in the previous section. To observe if there were differences between the larger steel balls and actual erodant particles, the surfaces of annealed copper and aluminum samples were impacted by compacts of erodant particles of aluminum oxide and silicon carbide and glass beads. Figure 9 shows micrographs of silicon carbide particles and glass beads. The aluminum oxide particles were similar to the silicon carbide particles in size and shape.

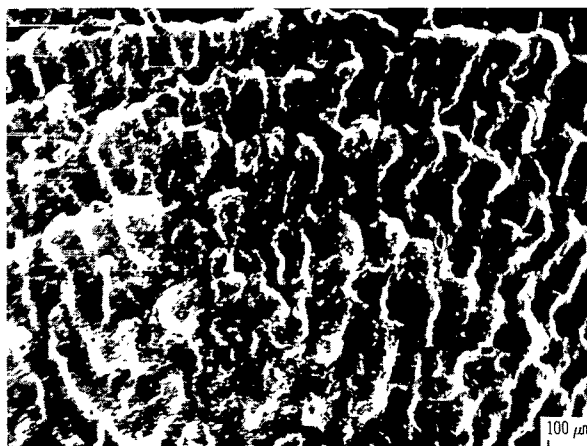
Figure 13. - Erosion crater in 6061 aluminum, produced by glass-bead impact.

The surface of aluminum after long exposure to the machine-produced, glass-bead stream is shown in figure 13. Ripples are observed on the eroded surface as reported and discussed by Finnie and Kabil (ref. 1). Higher magnification reveals the

lamellar structure that was observed for the impact of steel balls onto aluminum. This suggests that the prominent mechanism under those conditions is a deformation-induced fracture of surface layers. Since significant adhesion and material transfer occur for the steel-ball impacts into aluminum and copper, it is likely that adhesion between these smaller erodant particles and the metal may also occur. No evidence for aluminum transfer onto the glass beads was obtained by X-ray, however. For copper eroded by aluminum oxide particles, significant amounts of copper were detected on the "used" particles (fig. 14). For aluminum eroded by glass beads, it is likely that any transfer, if occurring, is in layers too thin to be detected by electron-beam-induced X-ray analysis but able to
